## **Glued-in basalt FRP rods as moment connections in box section frames**

# Glued-in Basalt FRP Rods as moment connections in box section frame corners

**ABSTRACT:** This paper presents an experimental programme that investigates the application of glued-in rods as moment connections in a post and beam connection. Nine such frame corners were constructed of box sections using a combination of sawn timber sections with orientated strand board and sawn sections with birch plywood. 12mm diameter basalt fibre reinforced polymer rods were used with a constant embedded length of  $23 \cdot d_r$  (280mm) and glueline thickness of  $0.125 \cdot d_r$  (2mm). Specimens with 2 no. and 3 no. rods were tested. Testing is ongoing at the time of writing this abstract therefore final conclusions cannot be drawn. However, early results show that the connection method is providing full moment transfer between the beam and post. In the OSB box sections failure was governed by the strength of the OSB beams, with the glued-in rods remaining fully intact.

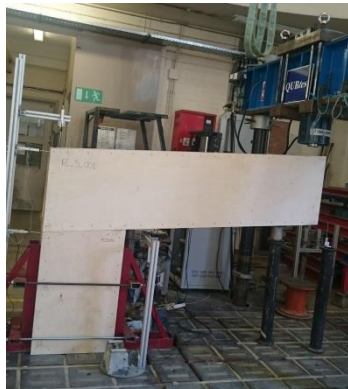
Specimens were tested in a UKCAS calibrated hydraulic actuator. Figure 3 shows the test setup used.

**Figure 3:** Test set-up

Load was applied in 1.0kN steps until ultimate failure. Deflection was measured at the tip under the load point, along the top face at the back end of the specimen and near to the pivot point. Slip at each side of the post was also recorded as well as rotation about the top left-hand corner. Strain was measured using ERS gauges mounted on the timber surface at the back surface close to the beam-post interface.
